Hillcrest Condominium Building #15
4800 hillcrest Lane
Hollywood, FL-33021

Concrete Deterioration Narrative Report

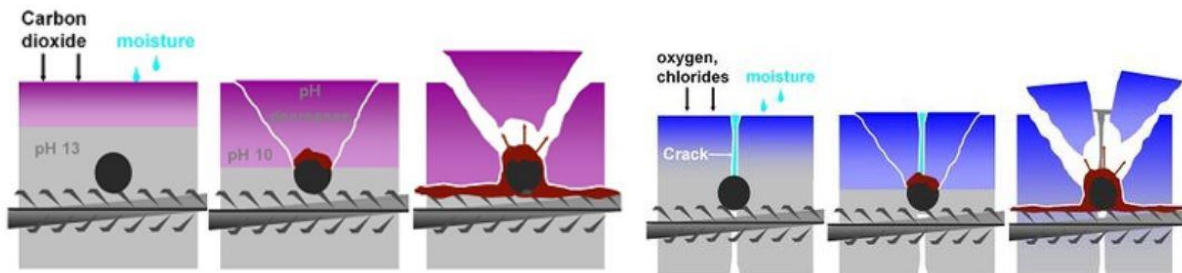
Concrete spalling indicates the final stage of concrete deterioration. It represents complete detachment and separation of pieces of concrete from the main structure, which will often lead to exposure of the rebar within the concrete. When the rebar becomes exposed to the exterior environment, it is prone to deterioration and corrosion. Corroded rebar expands and introduces additional pressure into the structure; thus, it could potentially cause additional concrete cracking and spalling (See Figure 1).

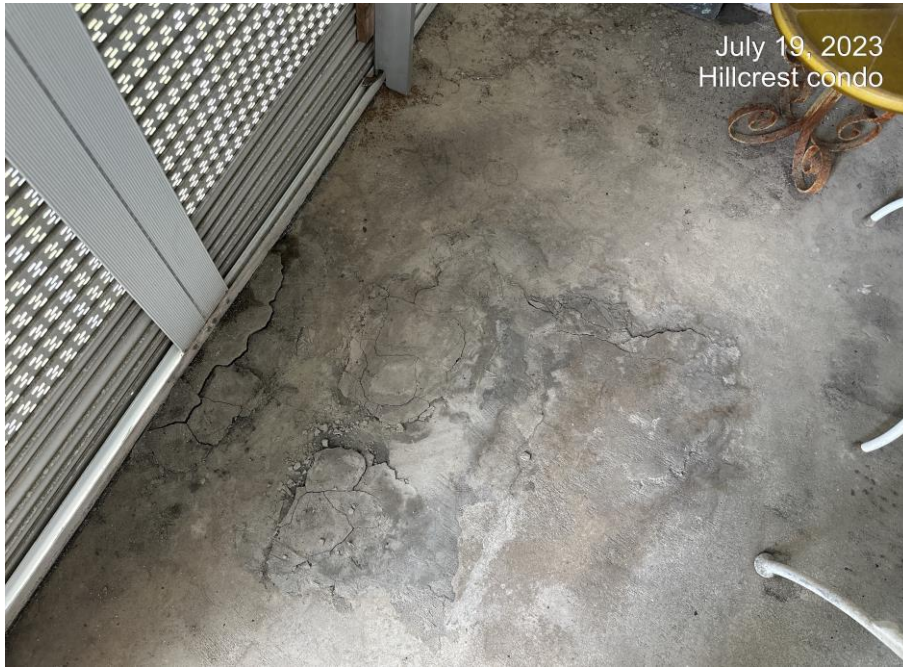
Photo 1: Spalled concrete on the balcony floor slab.

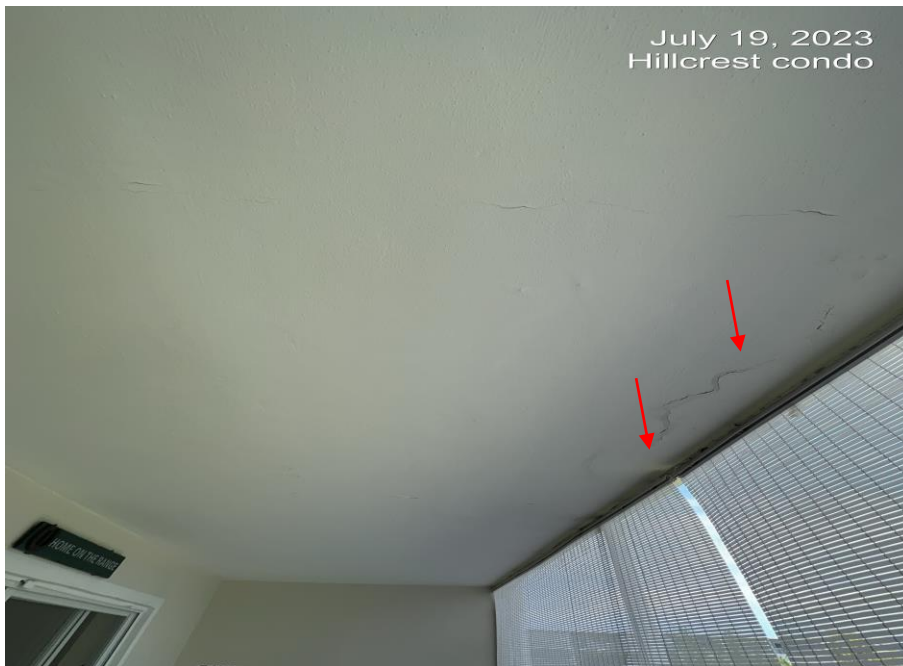
Photo 2: Multiple cracks on the overhead slab.

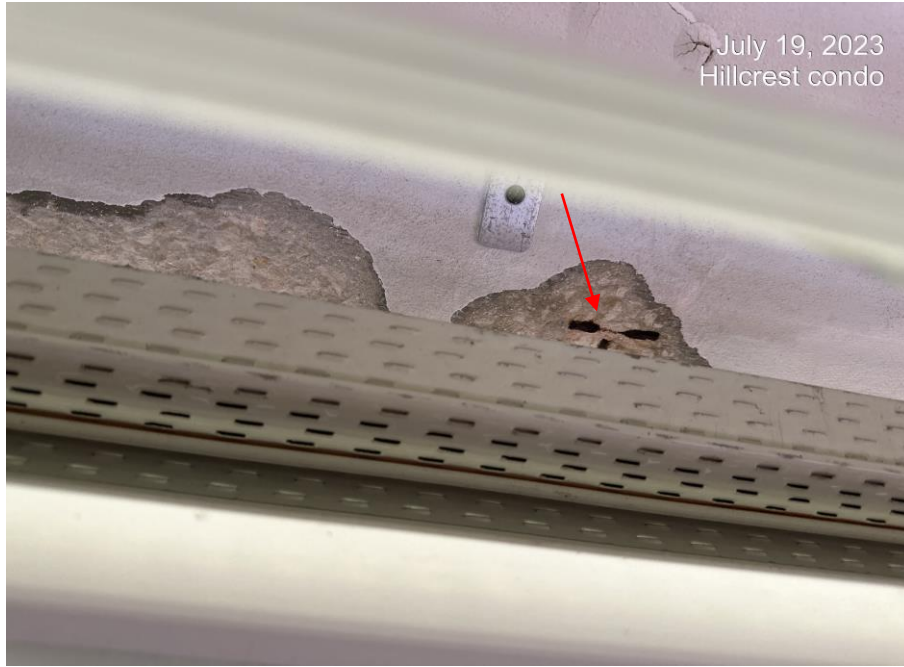
Photo 3: Spalled concrete and exposed corroded rebar in the overhead slab.

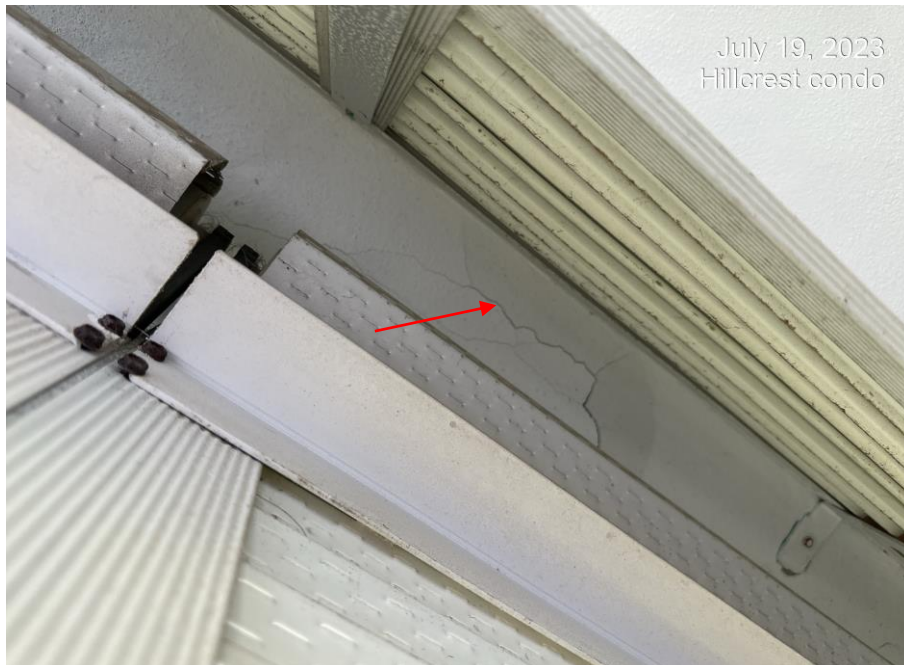
Photo 4: Cracks on the overhead slab.

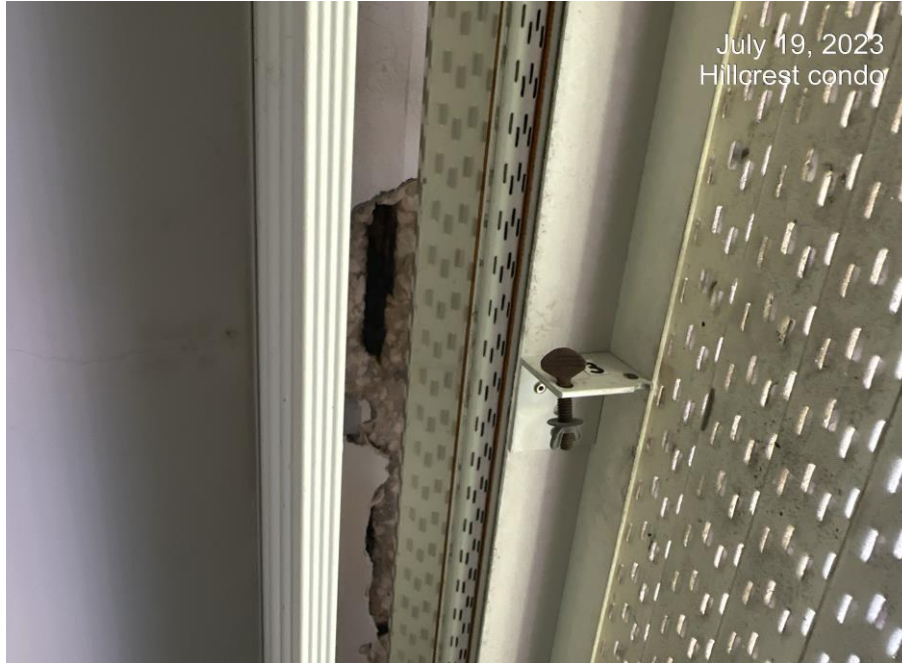
Photo 5: Spalled concrete and exposed corroded rebar in the overhead slab.

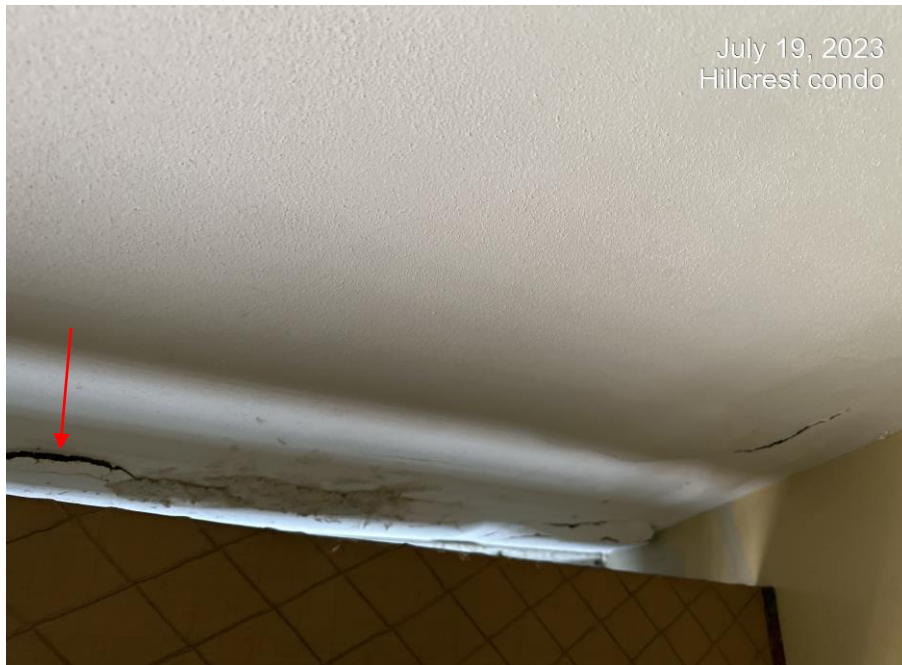
Photo 6: Spalled concrete in the overhead slab.

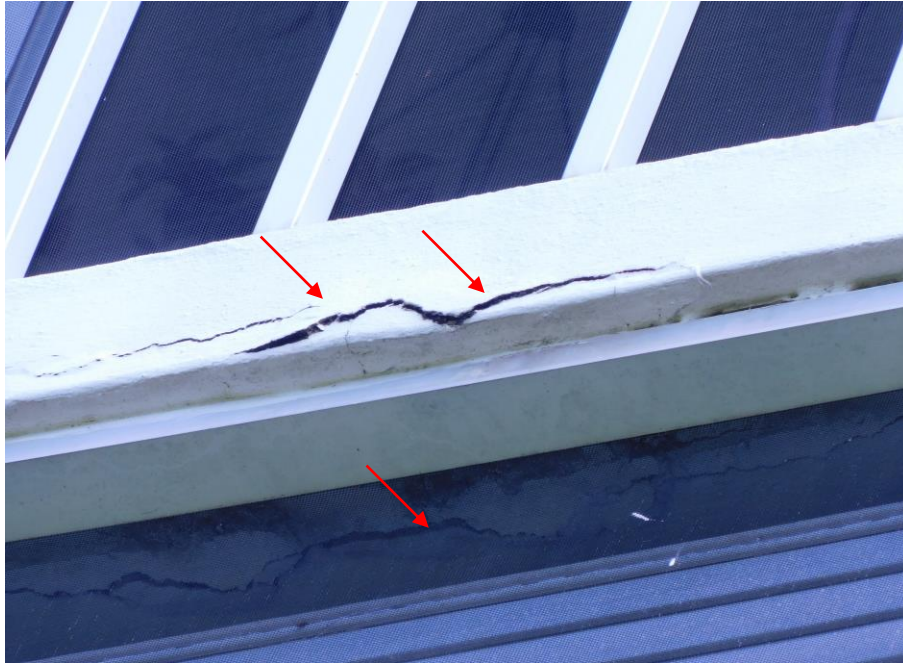
Photo 7: concrete spalling on the slab edge.

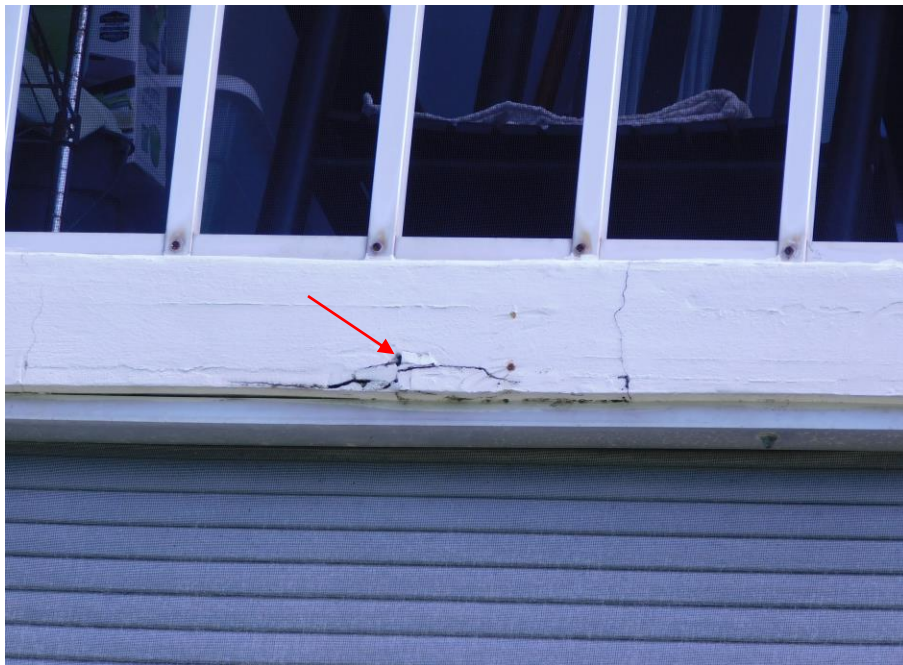
Photo 8: Concrete spalling and cracks on the slab edge.

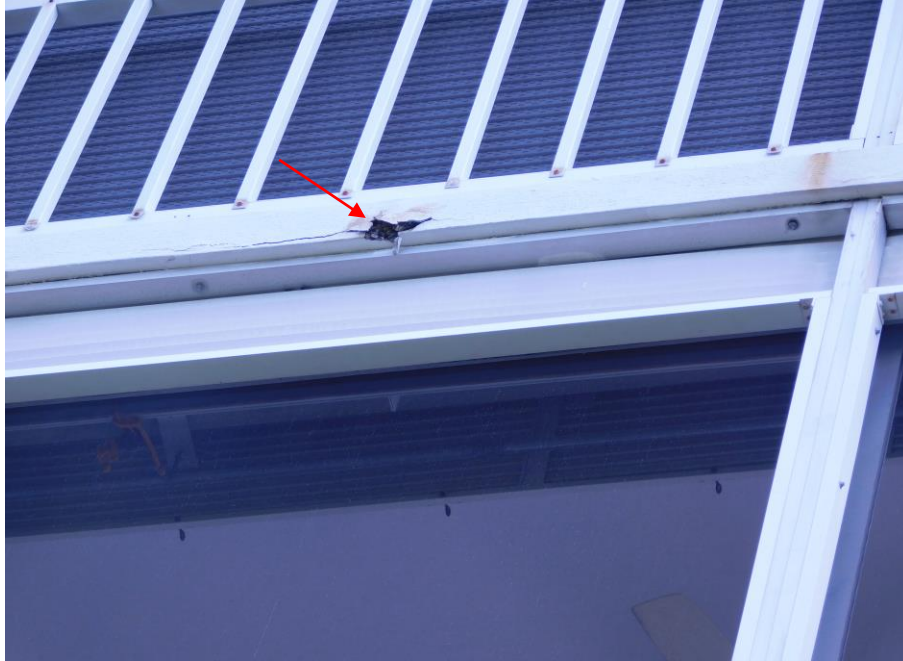
Photo 9: Concrete spalling and cracks on the slab edge.

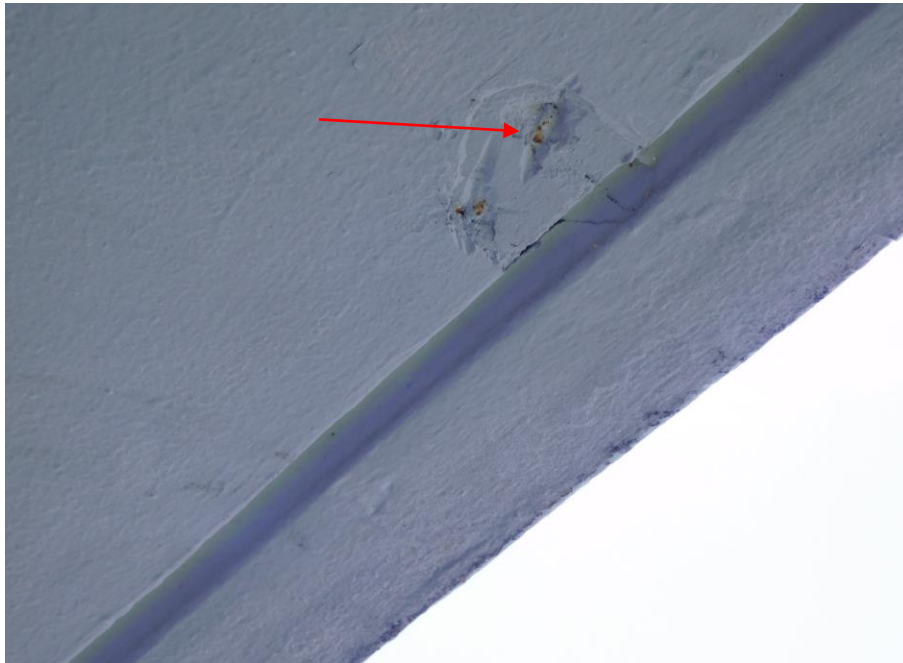
Photo 10: Exposed rebar on the overhead slab in the walkway.

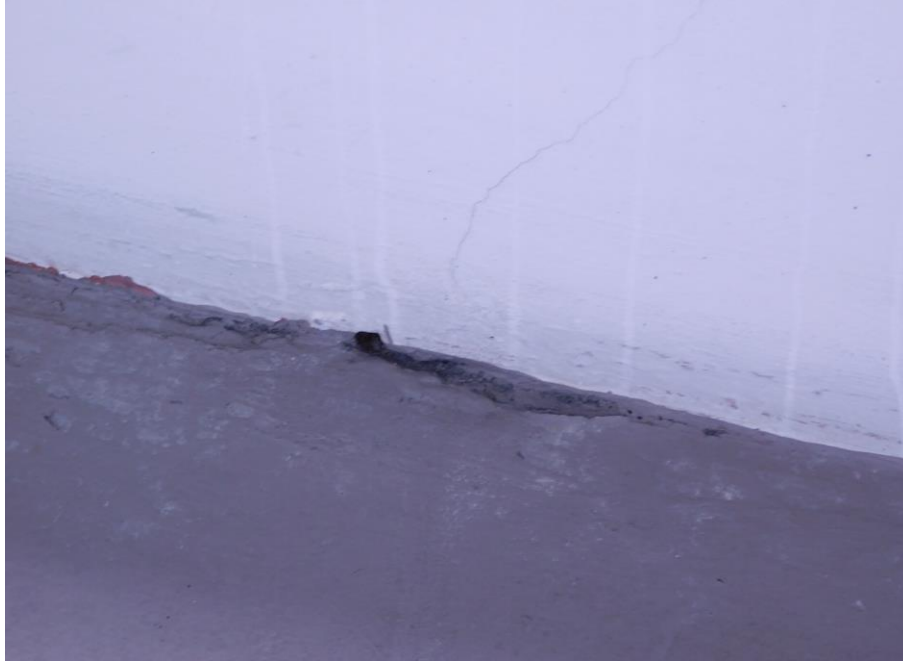
Photo 11: Cracks on the wall in the walkway.

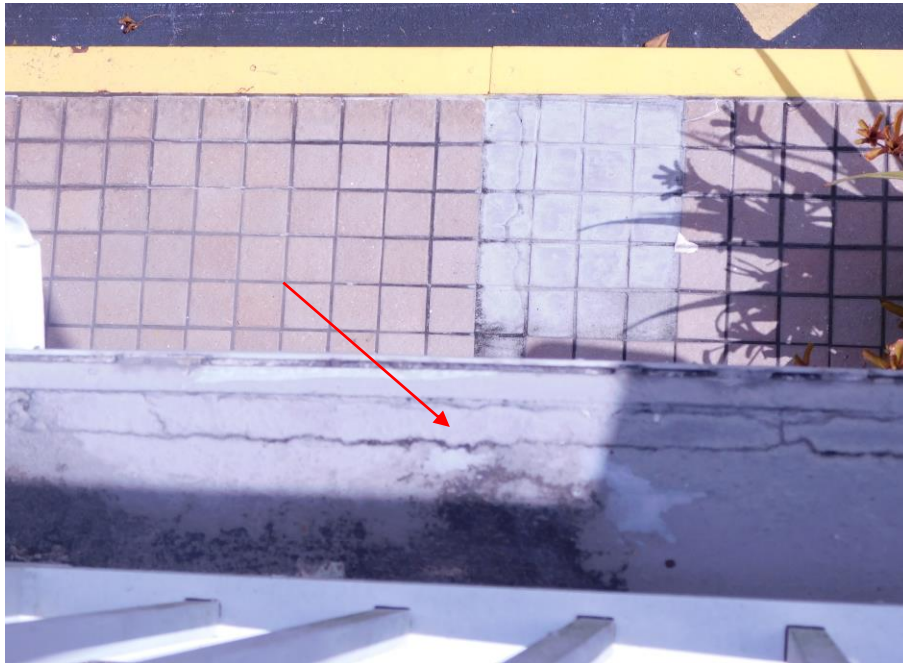
Photo 12: Cracks on the slab edge in the walkway

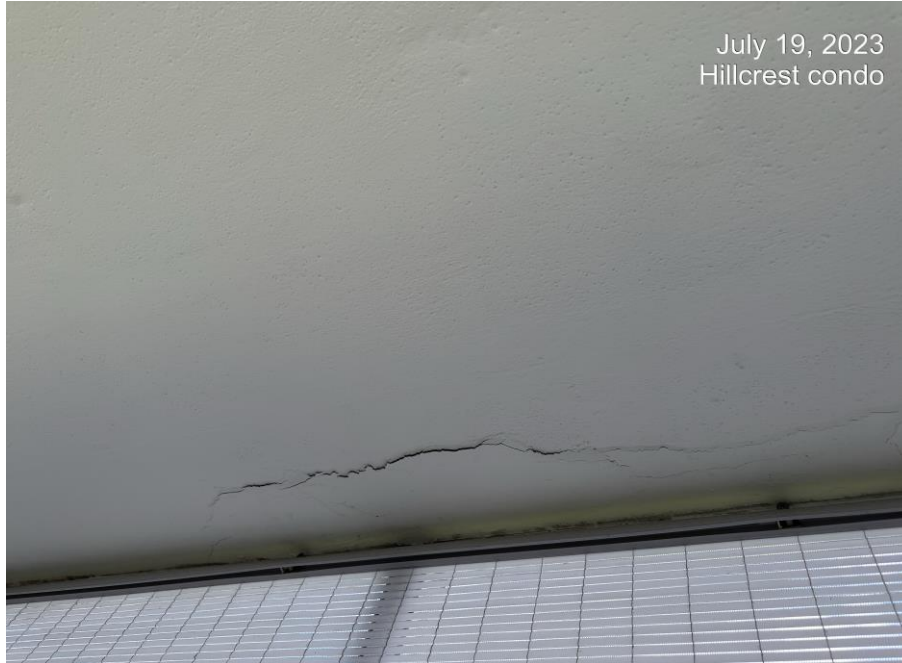
Photo 13: Cracks on the overhead slab in the balcony.

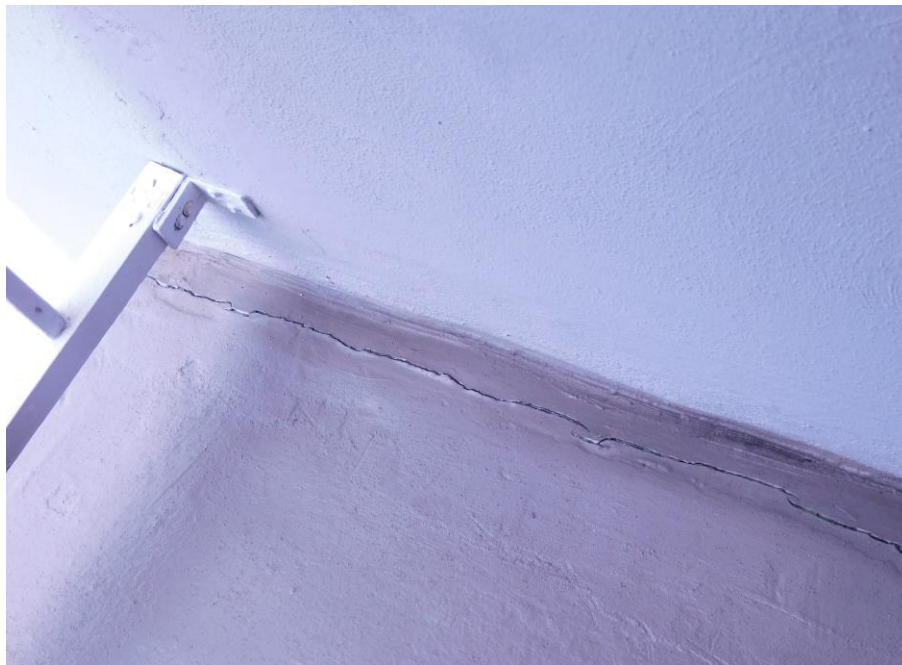
Photo 14: Cracks on the slab in the walkway.

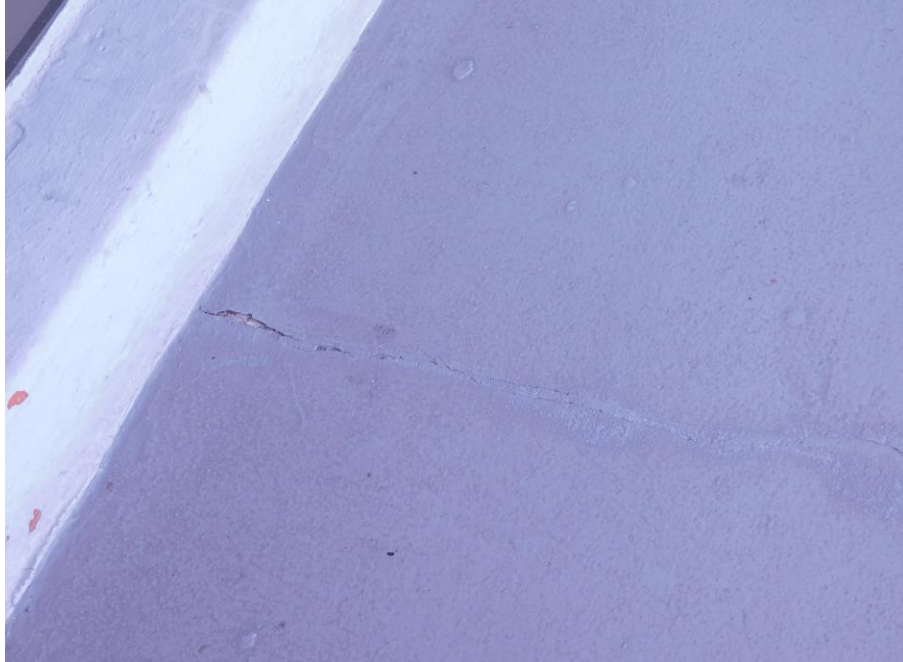
Photo 15: Cracks on the slab in the walkway.

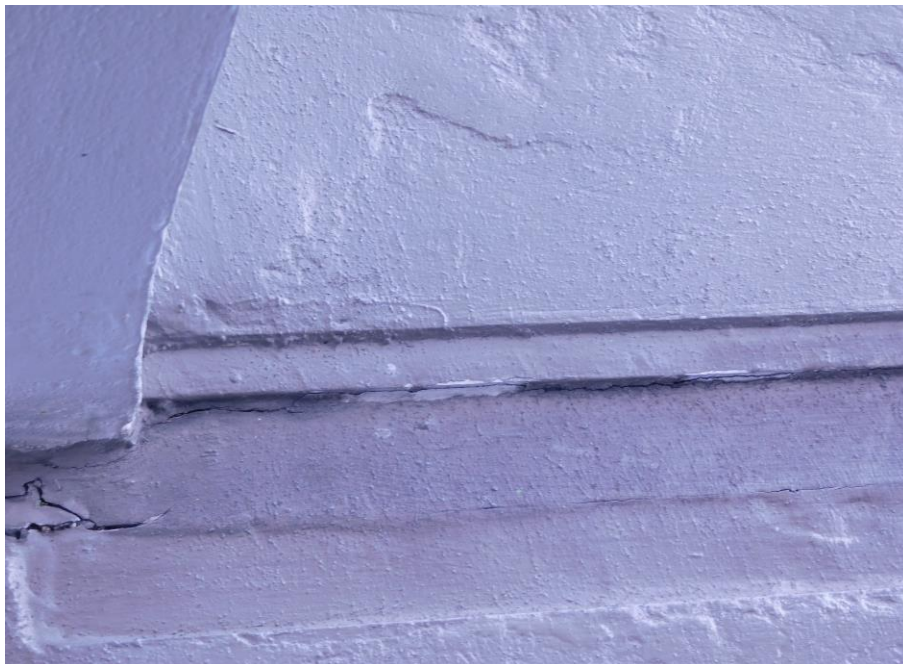
Photo 16: Cracks on the concrete slab in the walkway.
